Dry and Wet Testing of an Automated Fish Sorting System Which Uses Machine Vision

Kevin McCarthy

September 1988

Canadian Industry Report of Fisheries and Aquatic Sciences No. 191

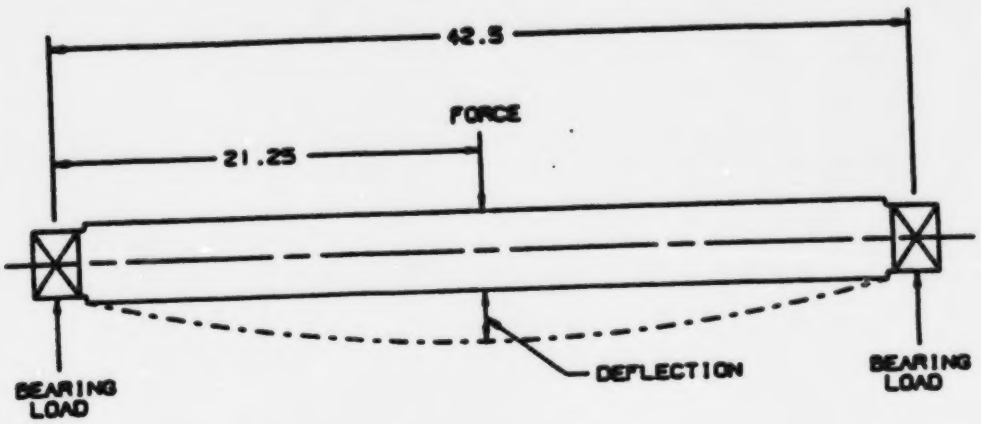
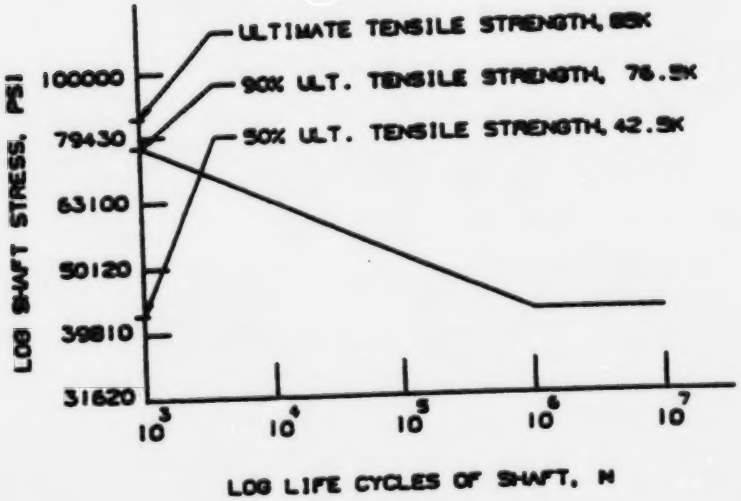
S-N DIAGRAM OF STAINLESS STEEL SHAFT

The actual dry run testing of the machine showed the unit easily met the performance guarantees. The only areas of of concern was the pivoting conveyor drive shaft. Drive shaft deflections of 0.050 inches to 0.055 inches were detected in the top pivoting position. Deflection was due to the fact that in this position, the pivoting air cylinder was not at right angles to the conveyor, thereby putting side forces on the conveyor and shaft. Cushioning built into the air cylinders did not appear to help.

A stress analysis of the shaft for various deflections and loadings was performed. The results are shown in the following section. Even at deflection of 0.1 inches, the lifespan of the 1 1/2" diameter drive shaft was not reduced. The only slight concern with shaft deflection was the wear effect back on the pivoting conveyor bearing and framework.

This study was done to determine the life cycle of the fish monitoring system take-off shaft. The shaft is 1.5" in diameter and 42.5" long. The existing condition has the shaft operating at 500 RPM. There is an unknown load at the centre and bearing supports at both ends. The observed deflection at the middle of the shaft is about 1/16".

The next step was to determine the life of the shaft. An S-N diagram was used. The diagram (next page) predicts the fatigue life of the shaft based on its stress load. The diagram indicates the life cycles would be infinite if the stress load is less than 50% of the ultimate tensile strength of a 304 stainless steel shaft is 85,000 PSI and the infinite life cycle level is at 42,500 PSI.

Considering the worst condition with 0.100" deflection on the shaft, the stress load is only 14,945 PSI, which is less than 42,500 PSI. Therefore, the shaft has an infinite life under the present loading conditions.
